The Physical and Human Causes of Erosion The Holderness Coast

By The British Geographer

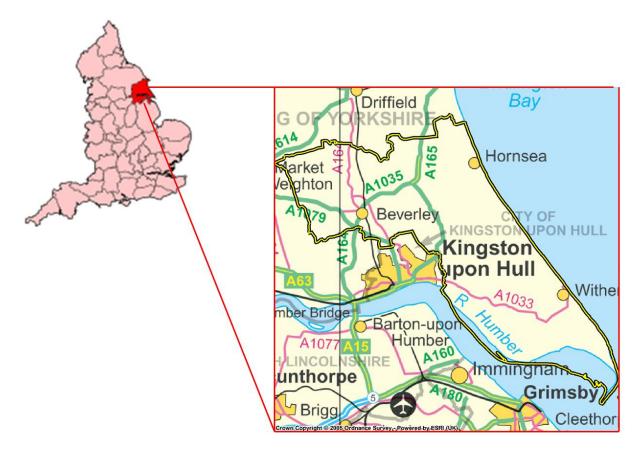
Figure 1

The Holderness coast is located on the east coast of England and is part of the East Riding of Yorkshire; a lowland agricultural region of England that lies between the chalk hills of the Wolds and the North Sea.

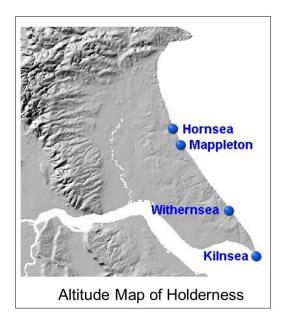
Figure 2

The geology and topography of the coastal plain and chalk hills can be seen in figure 2.

As we can see in figures 2 and 3, the Holderness Coast is a lowland coastal plain deposited by glaciers. The boulder clay is experiencing more rapid rates of erosion compared to the chalk. An outcrop of chalk can be seen to the north and forms the headland, Flamborough Head. The section of coastline is a 60 kilometre stretch from Flamborough Head in the north to Spurn Point in the south.

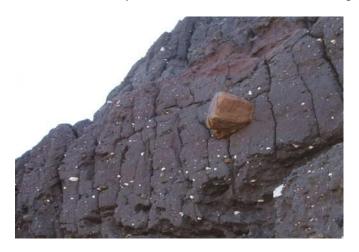
Figure 3

The boulder clay with erratics can be seen in figure 3.

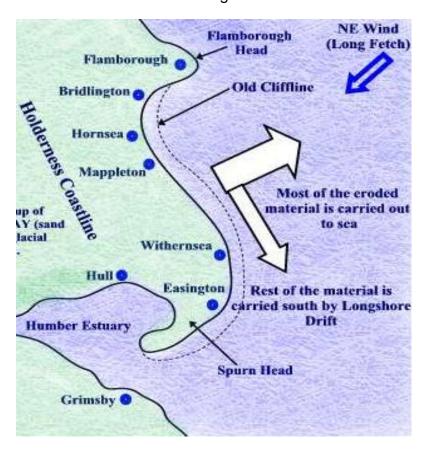
Figure 4

Marine processes play an important role at the Holderness coast. The size of fetch, the frequency of both sea storms associated with passing deperessions, and the process of longshore drift all act to limit the process of deposition to keep a narow beach. This can be seen in figure 4.

A long fetch under the influence of north-easterly winds creates larger waves with strong backwash that erode the exposed cliffs. The location of Holderness is on the track of mid-latitude depressions that increase the frequency of destructive waves. The proportional arrows show that double the amount of sediment is removed in the backwash than transported along the beach through longshore drift. These physical factors interrelate to ensure that beach material doesn't build up. Beach depth therefore remains narrow offering little protection to the weak boulder.clay cliffs.

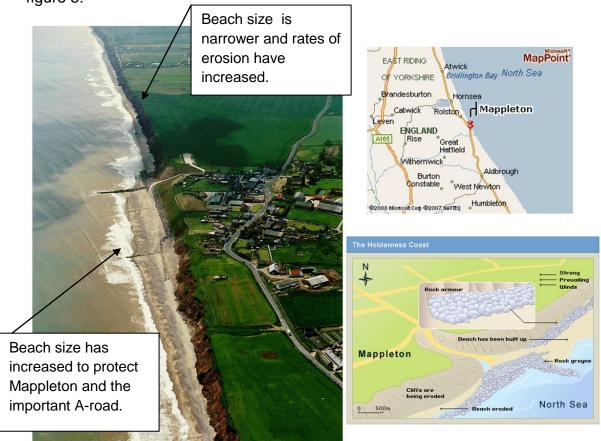
Figure 5

The influence of groynes is evident at Mappleton. Here decison makers have protected the base of the cliff with rock armour and placed two large rock armour groynes to act as groynes to build up the size of the beach. The effects are visible in figure 5:

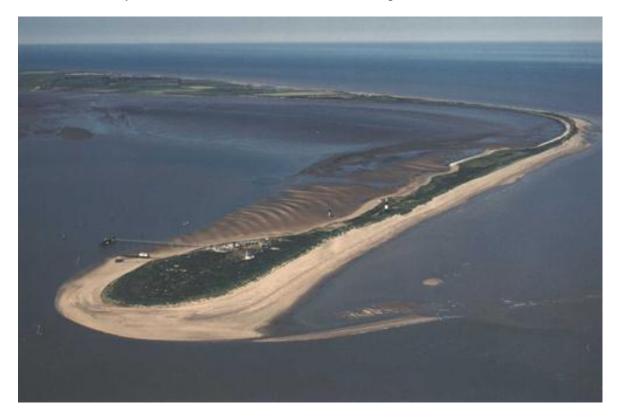
Figure 6

One final consequence of human cuased erosion is the threrat to Spurn Head, at the Humber Estuary. Spurn Head is a spit, which supports a small salt marsh. However, due to the constant interuption of longshore drfit along the Holderness Coast its sediment balance has been altered. This led to the loss of the old village of Kilnsea,

which was a functioning village in 1900. Today Spurn Head is dangerously narrow and could easily be breached. This can be seen in figure 6.

Figure 3: The Holderness coast, showing its retreat since Roman times
